Urgent Field Safety Notice

Subject: Liko® Viking® L, Viking® M, Viking® XL , and Viking® 300 Mobile Lifts – Potential Actuator Damage

FSCA-identifier: Mod 1228

Type of action: Corrective Action Notification

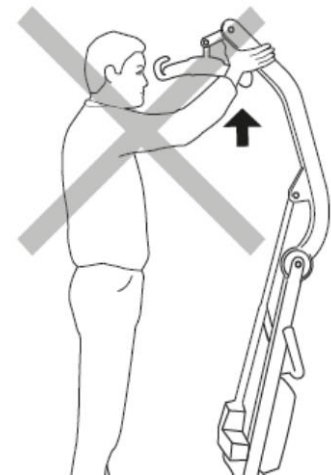
This issue is preceded by users who lift the lift arm assembly manually, as shown in the illustration to the right.

The lift arm assembly is intended to only be lifted by the actuator (lift motor). If the lift arm assembly is manually lifted, the actuator can become damaged and get stuck in the highest position. When the actuator is stuck, the lift cannot be raised/lowered by the lift motor. If a patient is lifted into the sling while the actuator is stuck, there is a potential risk of a free fall of the patient. This hazard could cause minor or potentially catastrophic injuries to a patient if the free fall encompasses the entire stroke of the actuator.

Hill-Rom is sending a customer notification requesting customers not to raise the lift arm manually since the lifting actuator can become stuck and/or become damaged. Customers will be instructed to always use the hand controls or the control box to operate the lift. There are no hazards when using the device as intended. Hill-Rom is updating the product labelling to address this hazard with the attached customer notification we expect you to forward to your customers.

Hill-Rom is concerned that the actuator may have become damaged from manually lifting, therefore, is more susceptible to becoming stuck in the highest position if manually lifted again. To reduce the risk of this occurring, Hill-Rom is announcing a correction that will include an inspection of all potentially affected Viking® lifts. If there is damage to the actuator, it will be replaced.

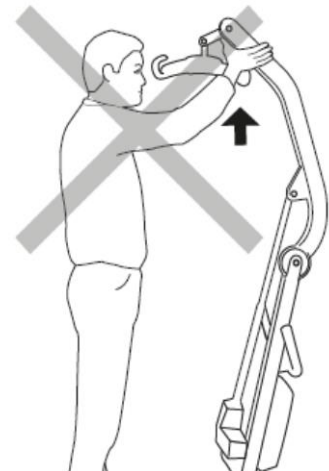
This issue is preceded by users who lift the lift arm assembly manually, as shown in the illustration to the right.

The lift arm assembly is intended to only be lifted by the actuator (lift motor). If the lift arm assembly is manually lifted, the actuator can become damaged and get stuck in the highest position. When the actuator is stuck, the lift cannot be raised/lowered by the lift motor. If a patient is lifted into the sling while the actuator is stuck, there is a potential risk of a free fall of the patient. This hazard could cause minor or potentially catastrophic injuries to a patient if the free fall encompasses the entire stroke of the actuator.

Hill-Rom requests customers not to raise the lift arm manually since the lifting actuator can become stuck and/or become damaged. Always use the hand controls or the control box to operate the lift. There are no hazards when using the device as intended. Hill-Rom is updating the product labelling to address this hazard.

Hill-Rom is concerned that the actuator may have become damaged from manually lifting, therefore, is more susceptible to becoming stuck in the highest position if manually lifted again. To reduce the risk of this occurring, Hill-Rom is announcing a correction that will include an inspection of all potentially affected Viking® lifts. If there is damage to the actuator, it will be replaced.

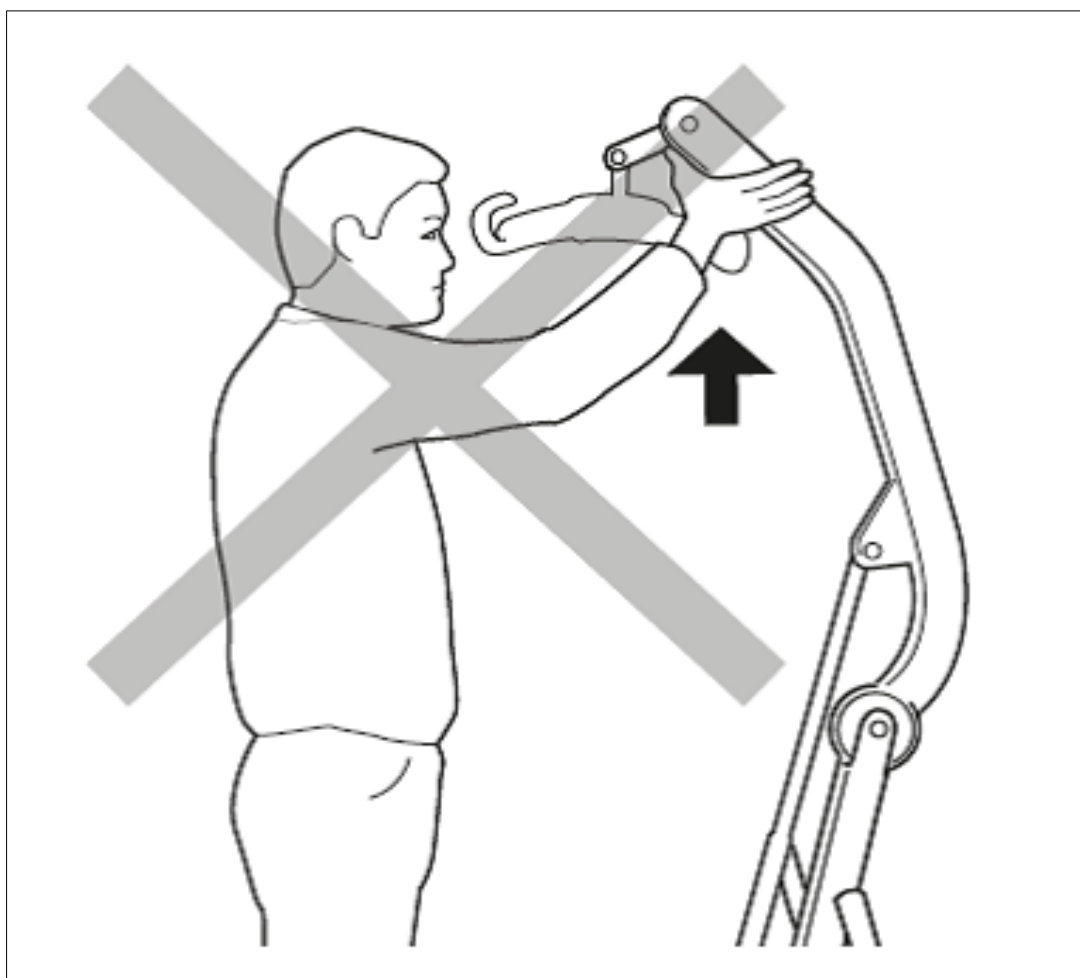
Insert for your Viking® Lift Instruction Guide

**△ Do not raise
the lift arm
manually!**
