**URGENT – MEDICAL DEVICE RECALL FOR PRODUCT CORRECTION**

**Invacare® TDX® series and Storm Series® power wheelchairs with 20”-24” width configurations with Formula CG Recline seating system (i.e. Tilt/Recline, Tilt/Recline/Elevate, or Recline only) and a conventional style back.**

**ARTG: 160385**

APRIL 28th, 2015

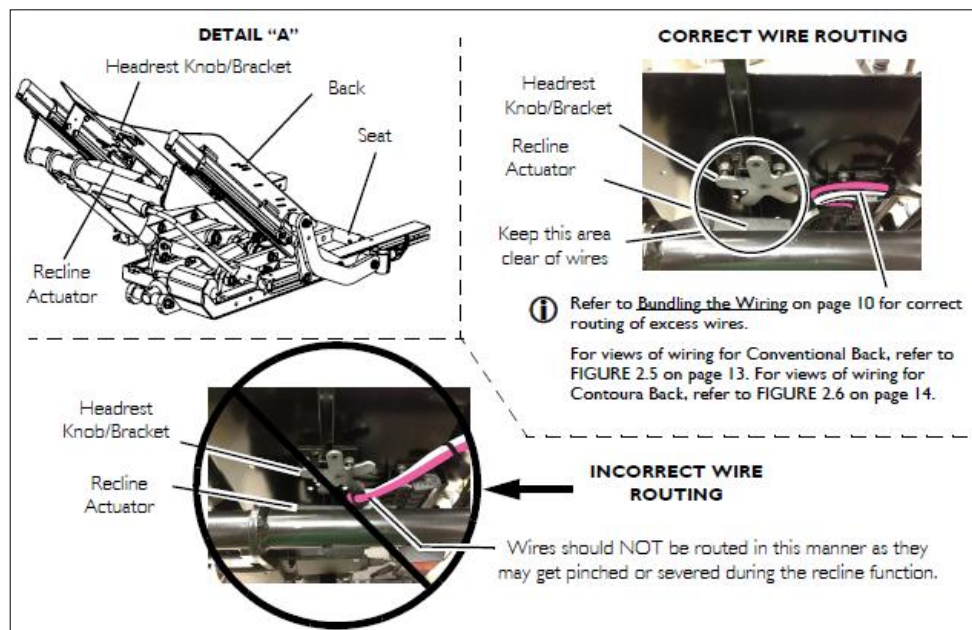
There is a possibility that if the slack in the wires is not routed and secured correctly, and with flexing of the back pan under the user’s weight, the headrest knob or clamp bracket may pinch, damage or cut the wire creating a hazard. Smoking, sparking, burning or fire may occur if any wire in this area is repetitively pinched, at the same location, over a period of time. Not all impacted chairs are expected to have slack in the wiring that is not routed and secured correctly.

1. Please promptly complete and return the enclosed Provider Response Card to Invacare by FAX 1800 814 367 or email to [recalls@invacare.com.au](mailto:recalls@invacare.com.au) to confirm receipt of recall notification and your agreement to conduct it according to instructions.
2. If you have further distributed this product, please identify the power wheelchair owners and notify them at once of this issue and proposed actions. A recommended consumer letter is enclosed for your reference, and should be mailed immediately upon receipt. Please contact your customer to schedule an appointment to inspect the potentially impacted power wheelchair as soon as possible.
3. A visual inspection of the wiring shall be conducted for each impacted chair. The figures below reference correct wiring (page 8 of Power Wheelchair Wiring Guide):

4. Verify that the wiring is routed and secured in accordance with the attached Power Wheelchair Wiring Guide. Invacare expects this inspection to take less than 10 minutes. **If the wiring is not as per the above figure, then the wiring should be corrected as directed in the wiring guide.**
5. Document confirmation of inspection and correction (if required) on the included Unit disposition form and Tracking Sheet and send Upon Invacare's receipt of the Unit disposition form and Tracking Sheet,
6. Invacare will apply a credit to your account for each corrected wiring. If the action is taken at your premises \$ 40.00. If a field action is required \$ 90.00. It is expected the inspection and any correction will take 10 minutes. Please ensure the paperwork is completed to receive the credit your account.
